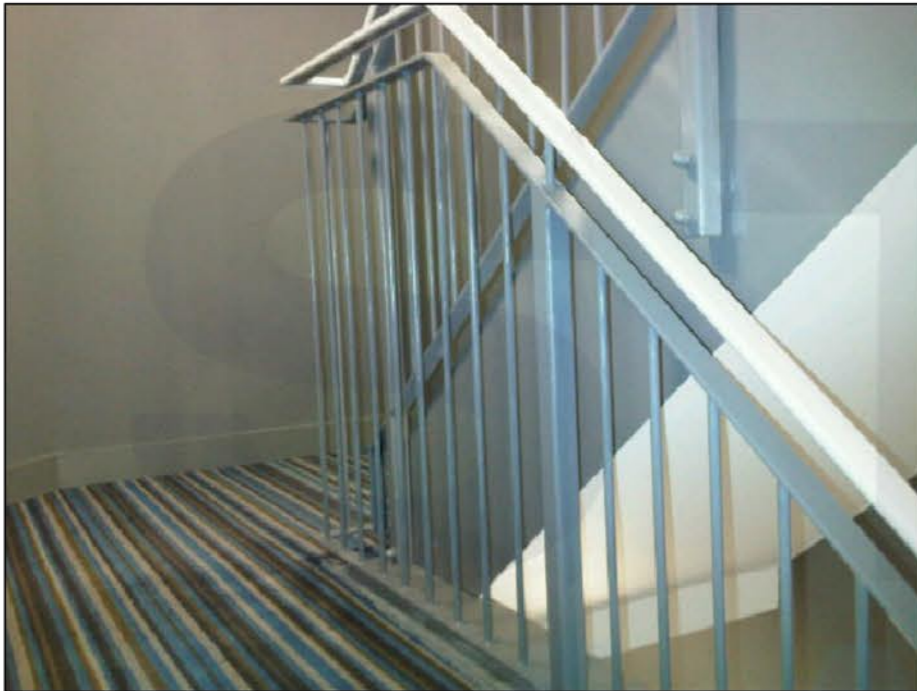
All angles are mitred and finished. Single coat Primer finish, suitable for further finishes
